WALLKILL RIVER BASIN
TRIBUTARY TO WALLKILL RIVER,
SUSSEX COUNTY
NEW JERSEY

LAKE PANORAMA DAM &

LAKE PANORAMA DIKE NJ 00816 & NJ 00828

PHASE 1 INSPECTION REPORT
NATIONAL DAM SAFETY PROGRAM

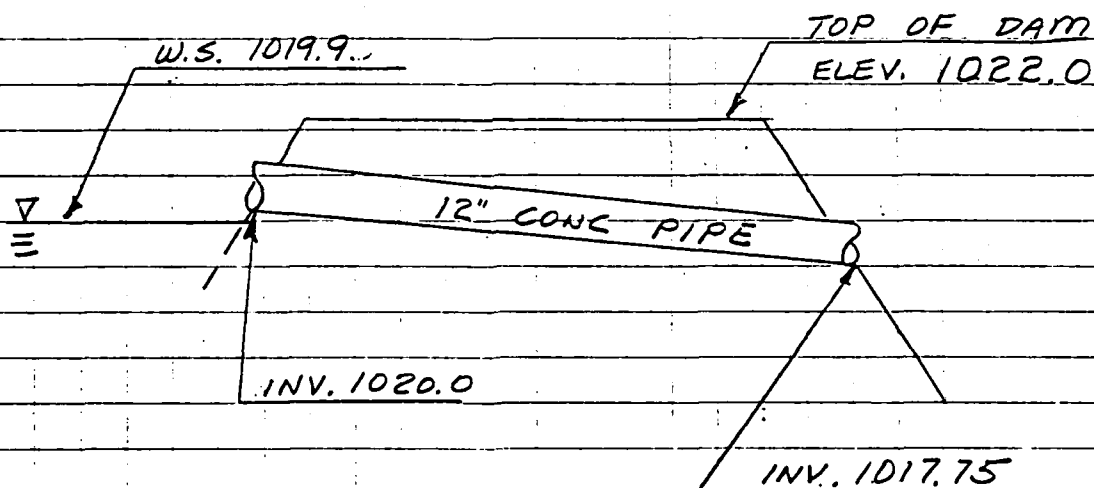
THE SPILLWAY AT THE LAKE PANORAMA DAM CONSISTS OF THREE 12" CONCRETE PIPES 28.2 FEET LONG WITH THE UPSTREAM INVERT BEING AT ELEVATION 1020.0 AND THE DOWNSTREAM INVERT BEING AT INVERT 1017.75.
